Assessment of Dam Safety of Coal Combustion Surface Impoundments

Indianapolis Power & Light Company

Harding Street Generating Station

November 15, 2010

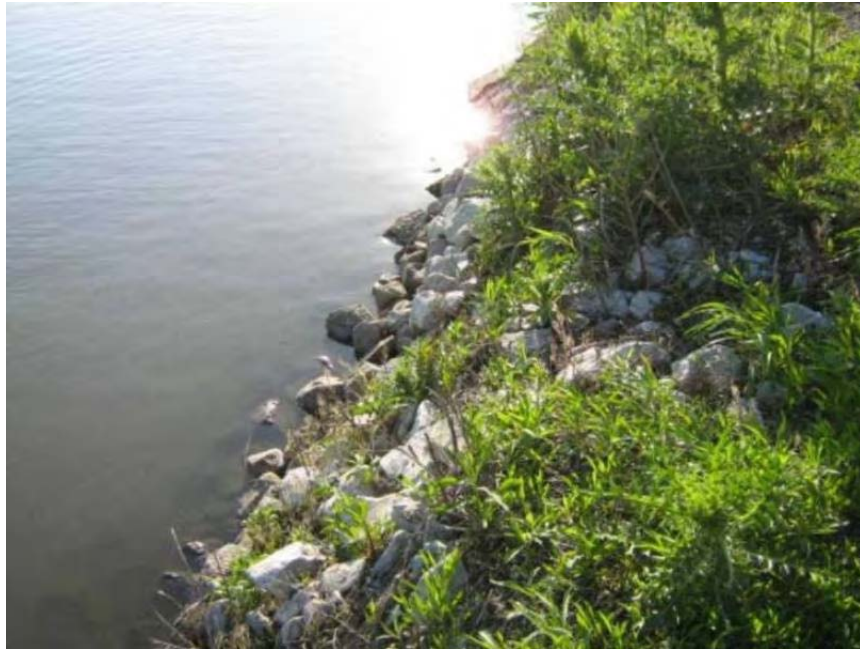
166. Ash Pond 4B - Riprap on South Embankment Interior Slope,
Looking East

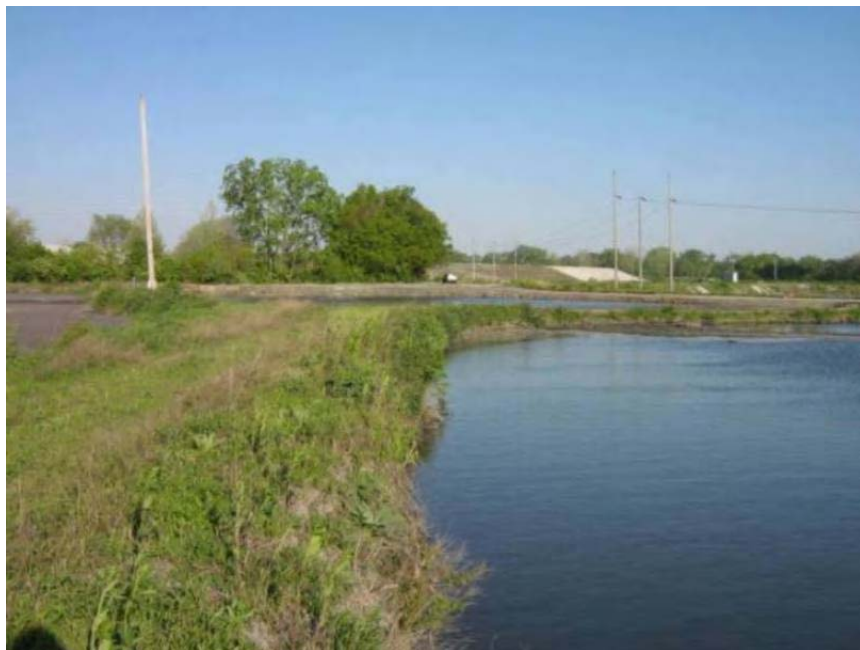
167. Ash Pond 4B - South Embankment Interior Slope, Looking
West

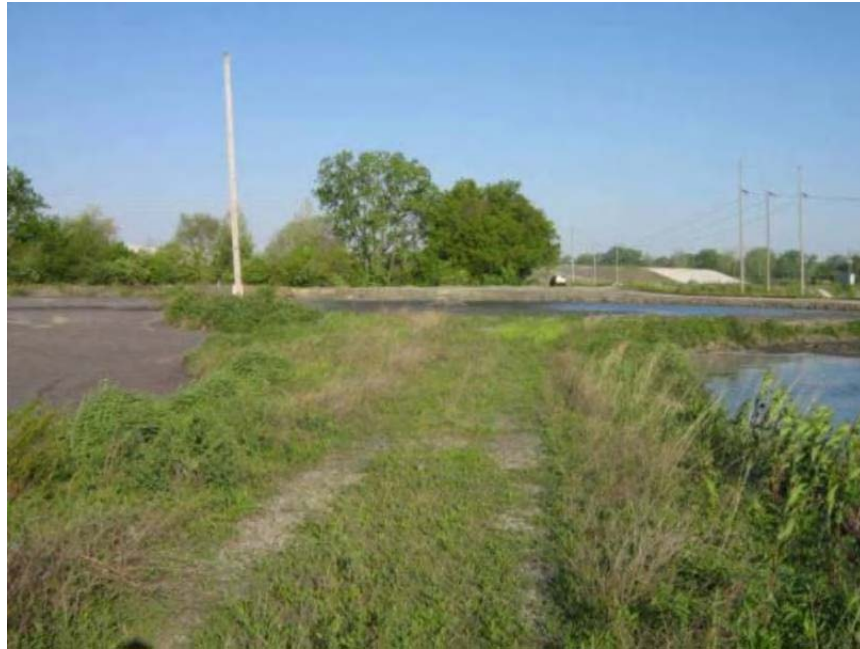
168. Ash Pond 4B - South Embankment Crest, Looking West

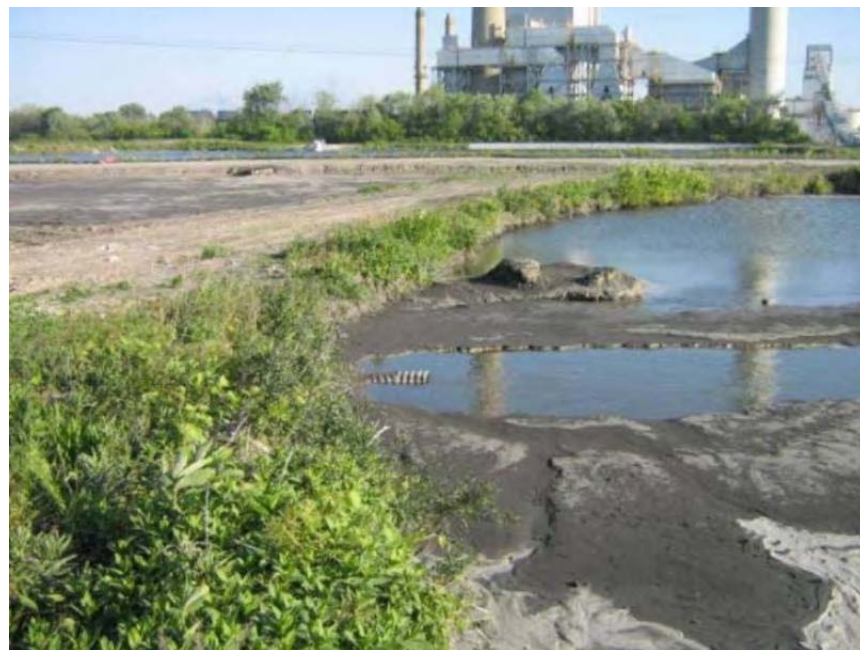
169. Ash Pond 4B - Inlet/Outlet to Ash Pond 4A located along West Embankment Interior Slope

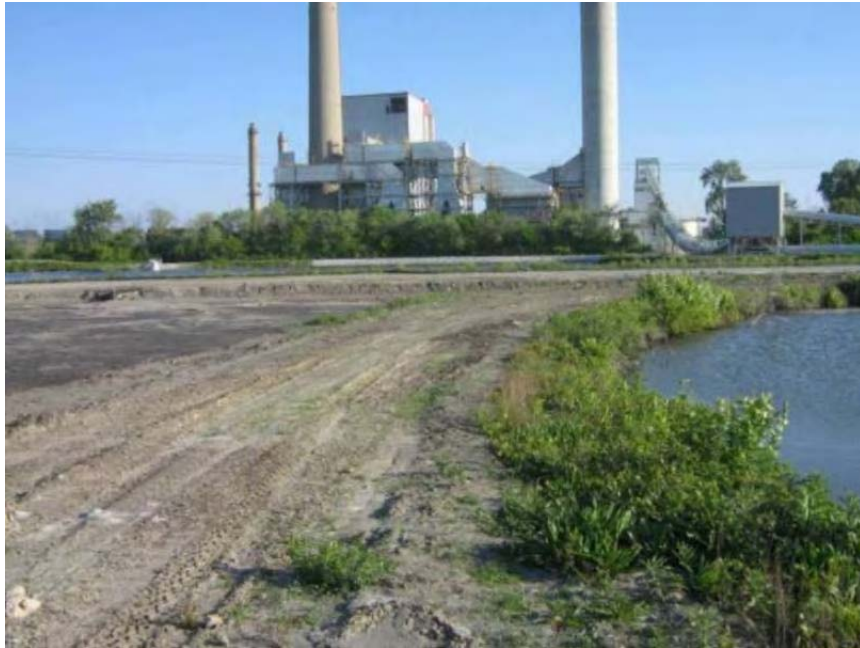
170. Ash Pond 4B - West Embankment Crest, Looking North, Ruts from Vehicle Traffic Visible
